Griffy Lake
Aquatic Vegetation Management Plan
Update

February 9, 2007

Prepared by:
Aquatic Control, Inc.
PO Box 100
Seymour, Indiana 47274

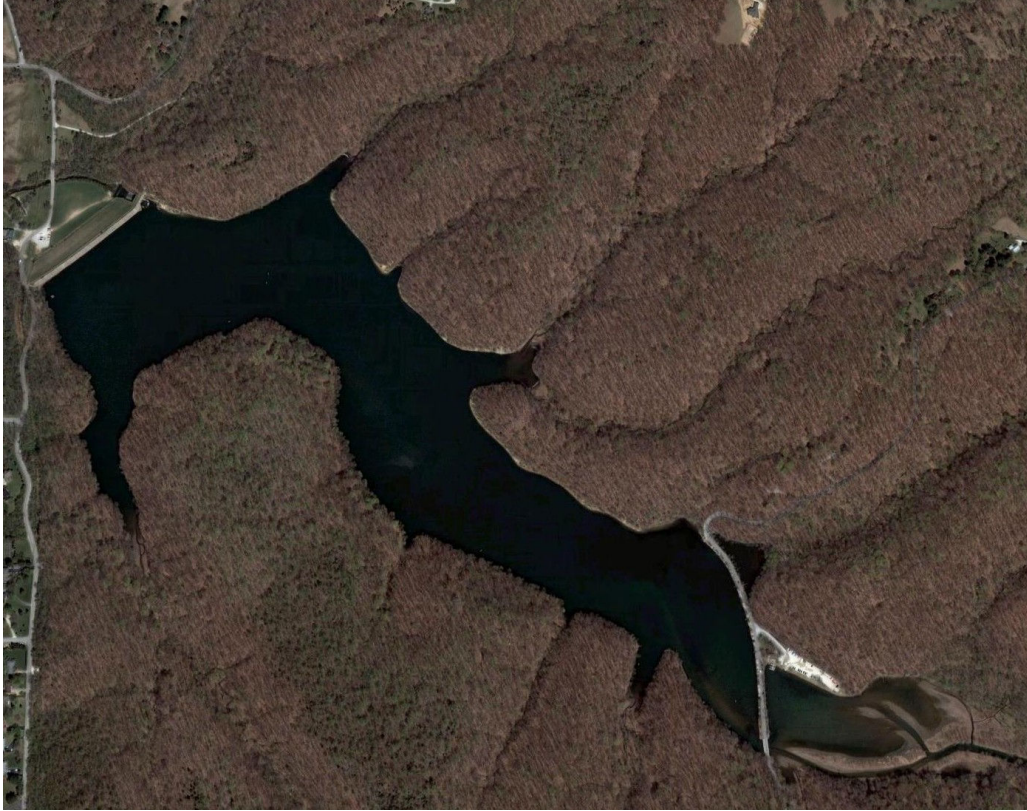
Figure 2. Tier I plant beds, Griffy Lake, August 8, 2006. Brazilian elodea was found in those beds shaded red.

On August 8, 2006 a tier I survey was completed on Griffy Lake. The tier I survey revealed 16 distinct plant beds within Griffy Lake totaling 42.5 acres. (Table 2 & Figure 2). Vegetation was present to a maximum depth of 18 feet. Eight different species were observed.

Rooted floating and emergent vegetation dominated plant beds 1, 3, and 13. These beds totaled 0.9 acres and were comprised of creeping water primrose (*Jussiaea repens*), common cattail (*Typha latifolia*), American water willow (*Dianthera americana*), and swamp rose mallow (*Hibiscus palustris*). Chara (*Chara spp.*) and common coontail (*Ceratophyllum demersum*) were the only submersed species found in these three beds.

Plant bed 2 was located in the upper end of Griffy Lake near the boat ramp. This area was estimated to be 9.9 acres. Chara was the dominant species in bed 2. Creeping water primrose and star duckweed (*Lemna trisulca*) were also observed at a much lower abundance.

Plant beds 4, 5, and 6 were all located in the upper end of Griffy Lake and had similar composition. Bed 4 included the area near the boat ramp and was estimated to be 2.2 acres. Common coontail was the most abundant species in this bed. Chara was also observed. Bed 5 included an area just west of the causeway and was 14.6 acres. Chara was more abundant than coontail in bed 5. American water willow was also documented in this area. Bed 6 included the small pond that is connected to Griffy Lake and just east of bed 5. This bed totaled 1.1 acres and was comprised mainly of coontail.

Plant bed 7 included a 1.8-acre area along the north-shore of Griffy Lake. Chara dominated plant bed 7 and was at or near the surface. American water willow, creeping water primrose, and common coontail were also observed.

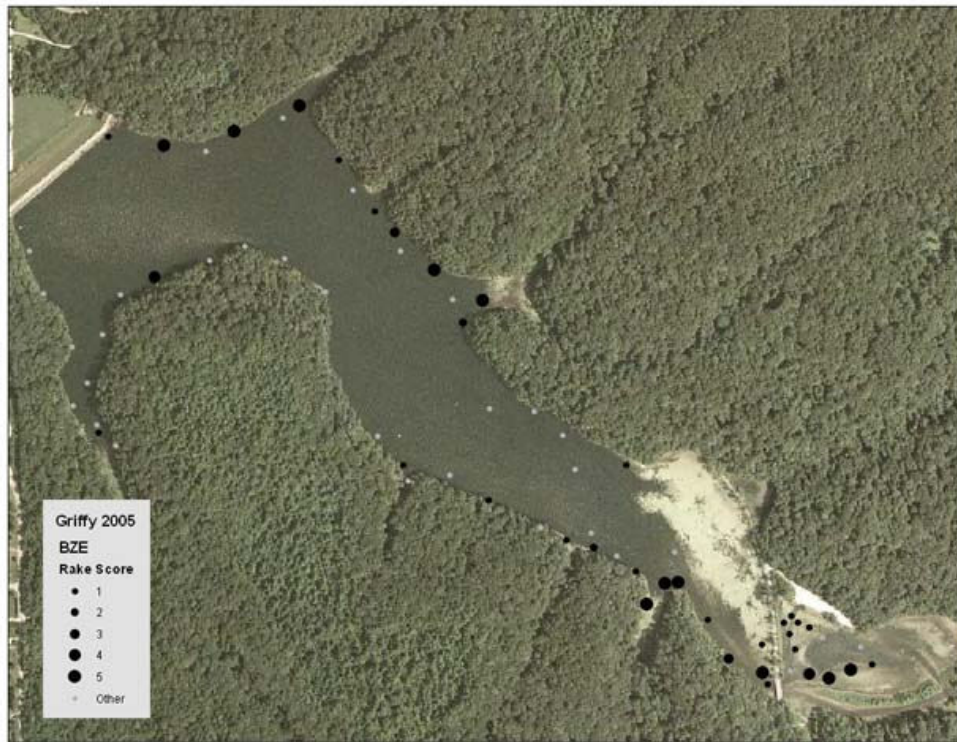
Figure 1. Griffy Lake, location and density of Brazilian elodea, July 11, 2005.

District fisheries biologists from the Department of Natural Resources completed plant sampling in 2005. Sampling took place on July 11 and consisted of a Tier II survey. Prior to surveying, a Secchi measurement was taken and found to be 7.5 feet. Seventy-two sites were sampled and 68 of those sites had plants. A total of 11 species were identified. Coontail was the most abundant species collected (72.6% of sites), followed by Eurasian watermilfoil (69.9%), Brazilian elodea (49.3%), and brittle naiad (17.8%). Common naiad, curlyleaf pondweed, American pondweed, Chara, creeping water primrose, sago pondweed, and small pondweed were also collected at a lower percent occurrence (Table 1). Location and density of Brazilian elodea is illustrated in Figure 1.

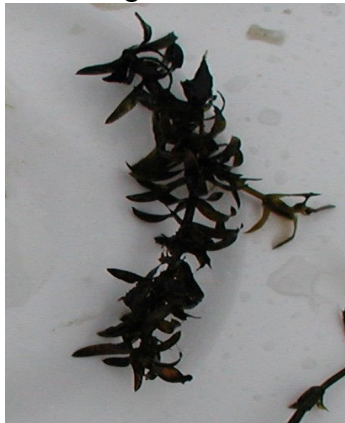
Figure 3. Brazilian elodea stem after treatment (photo taken May 11, 2006).

Plant beds 9, 12, and 16 were the only beds in which Brazilian elodea was observed. These beds were estimated to be 1.4 acres in area. Bed 9 was located between beds 8 and 10 near the first cove on the north side of the lake. This area was determined to be approximately 0.1 acres. Chara was the most abundant species in bed 9. Creeping water primrose, water willow, and Brazilian elodea were also present a lower abundance ratings. Bed 12 was located near the overflow and was found to be 0.1 acres. American water willow was the most abundant species in bed 12. Chara, common coontail, and Brazilian elodea were also observed. Bed 16 was the largest bed in which Brazilian elodea was observed. Bed 16 encompassed an area of 1.2 acres. Brazilian elodea, common coontail, and Chara were all observed in this bed at a low abundance. Brazilian elodea in these areas appeared to have been damaged from the sonar treatment. The stems were black in appearance and contained no roots (Figure 3). It was not clear whether it would recover from this damage.

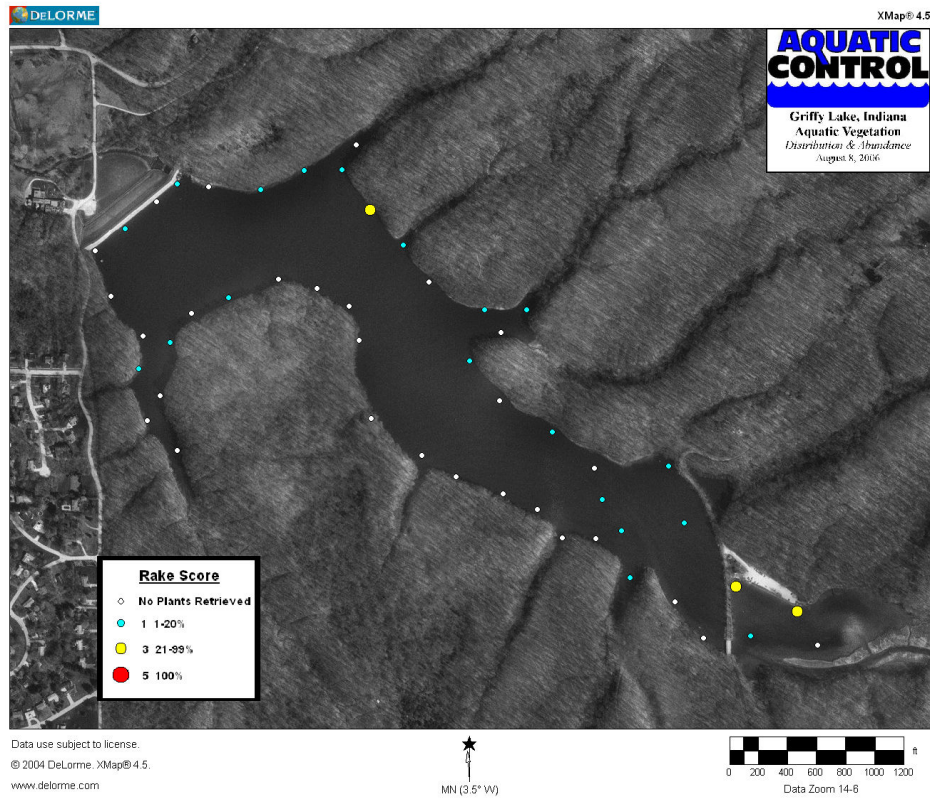
Figure 4. Griffy Lake aquatic vegetation distribution and abundance, August 8, 2006.

Tier II sampling took place immediately following the tier I survey. Table 3 outlines the survey results. A total of 50 sites were surveyed throughout the littoral zone of the lake. Eighteen sites were located between 0-5 feet, sixteen sites from 5-10 feet, sixteen sites between 10-15 feet, and ten sites from 15-20 feet. Maximum plant depth was determined to be 18 feet. Plants were present at 22 of the sample sites. A total of four species were sampled, all of which were native except Brazilian elodea. The maximum number of species collected at a site was 3. The overall location and density of aquatic vegetation is illustrated in Figure 4.

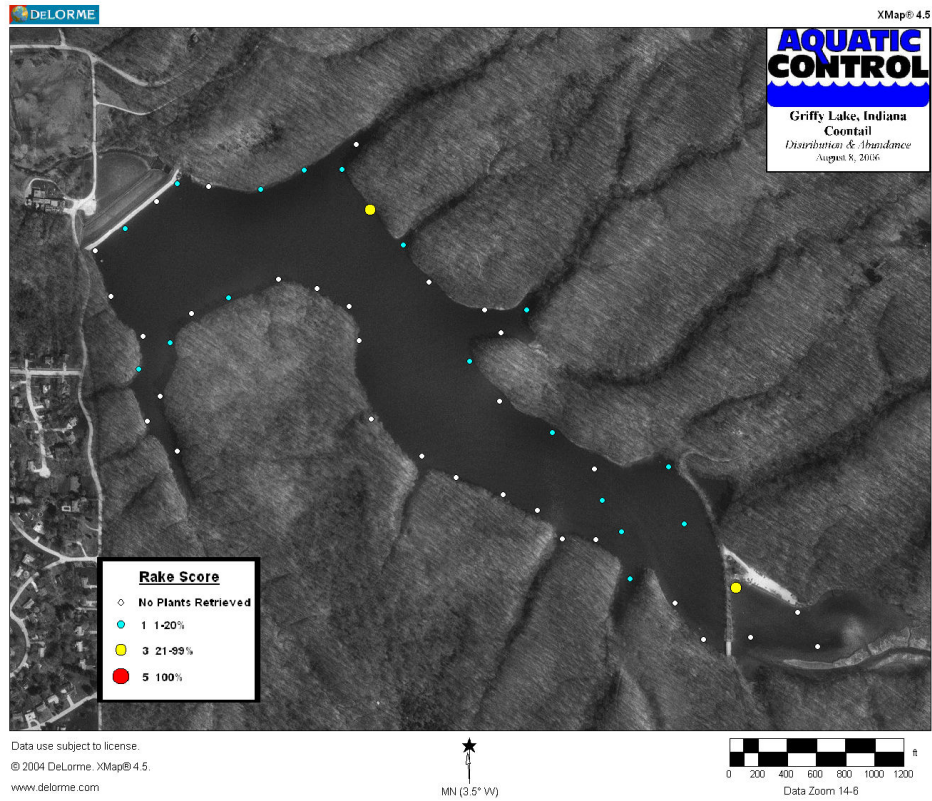
Figure 5. Griffy Lake, common coontail distribution and abundance, August 8, 2006.

Of the four species collected, common coontail had the highest frequency of occurrence (38%). Location and density of this species is illustrated in Figure 5. Chara and Brazilian elodea were both found at 10% of the sampling sites (Figure 6 & 7). Horned pondweed (*Zanichellia palustris*) was found at only a single sample site (Figure 8).

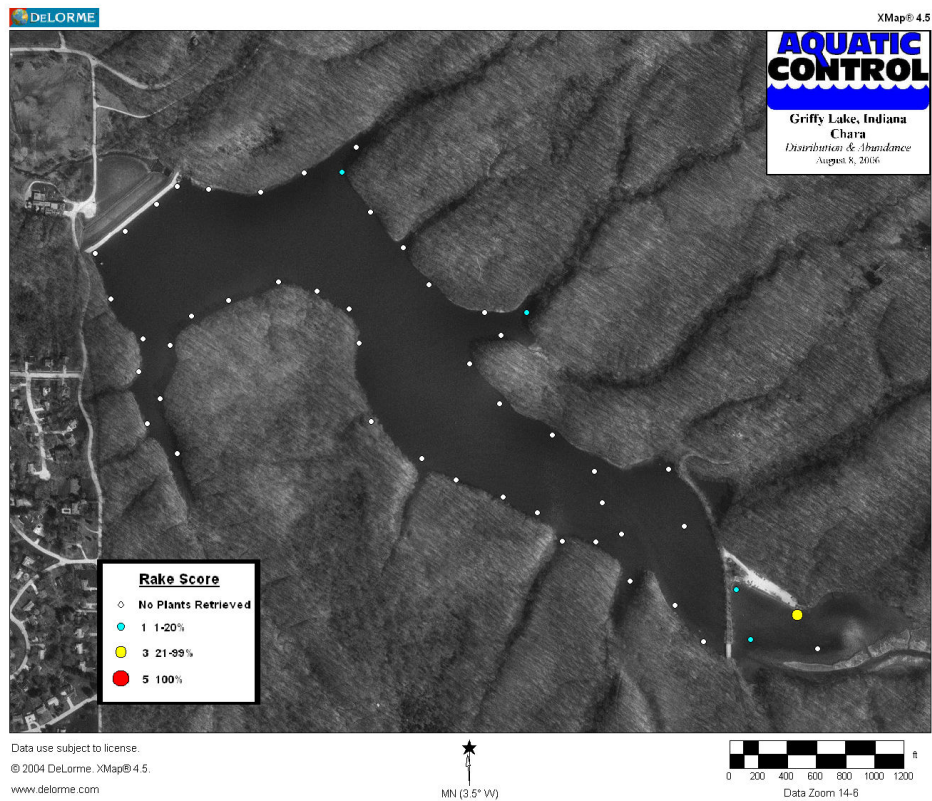
Figure 6. Griffy Lake, Chara distribution and abundance, August 8, 2006.

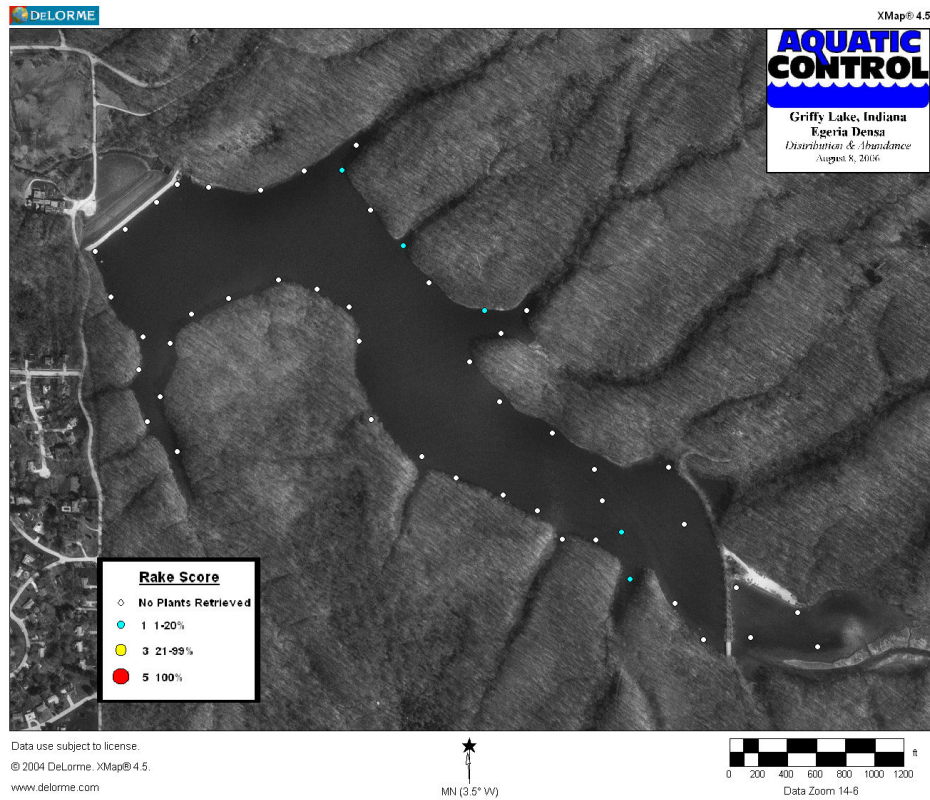
Figure 7. Griffy Lake, Brazilian elodea distribution and abundance, August 8, 2006.

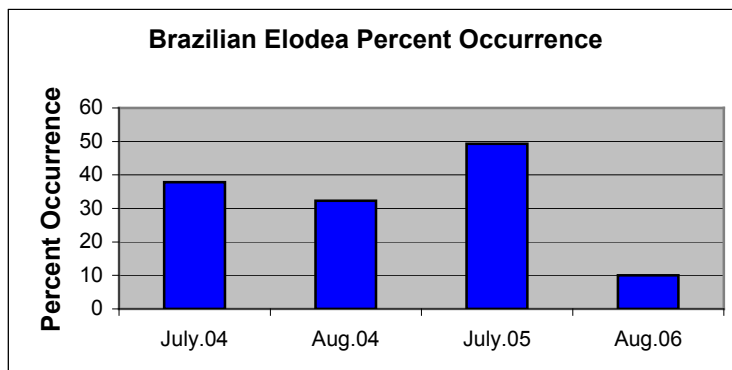
Figure 9. Griffy Lake, Brazilian elodea percent occurrence in the last four surveys (July 2004 and July 2005 data collected by IDNR).

The primary goal of the vegetation management plan is the eradication of Brazilian elodea. In order to meet this goal, a whole lake fluridone treatment was completed in 2006. Brazilian elodea was significantly reduced by the time the August survey was completed, however, there was still some plant material sampled (Figure 9). These plants were damaged and may not have survived, but they were included in the sample since they were identifiable. It was later determined that the plants likely had a 50% chance of survival and that another bump treatment should be completed (this will be discussed further in the treatment section). An informal survey of areas of concern was completed on October 31 and no Brazilian elodea plants were detected.

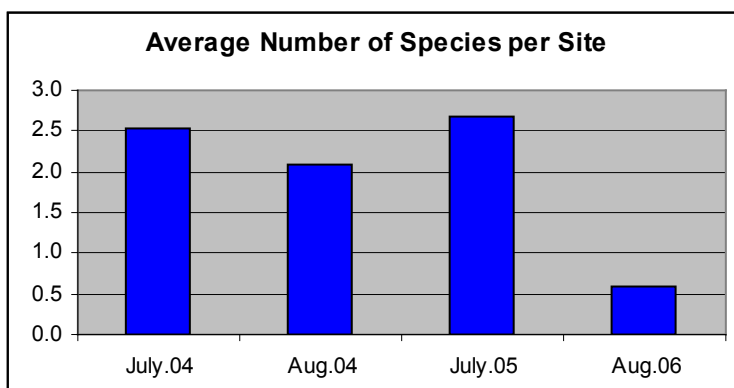
Figure 10. Griffy Lake, average number of species collected per site in the last four surveys (July 2004 and July 2005 data collected by IDNR).

From the outset of this treatment it was clear that there would be damage to the native plant population due to the need to use high rates of fluridone over an extended period of time. There was a reduction in plant diversity when compared to past surveys (Figure 10).

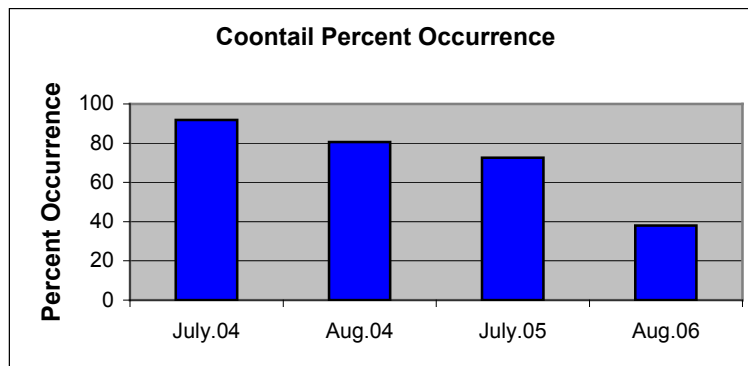
Figure 11. Griffy Lake, common coontail percent occurrence in the last four surveys (July 2004 and July 2005 data collected by IDNR).

Common coontail was one of the most abundant submersed plant species prior to the fluridone treatment. This species is susceptible to fluridone at low to moderate rates over extended times. Coontail was damaged by the treatment, but was still the most abundant species present in the August sampling (Figure 11).

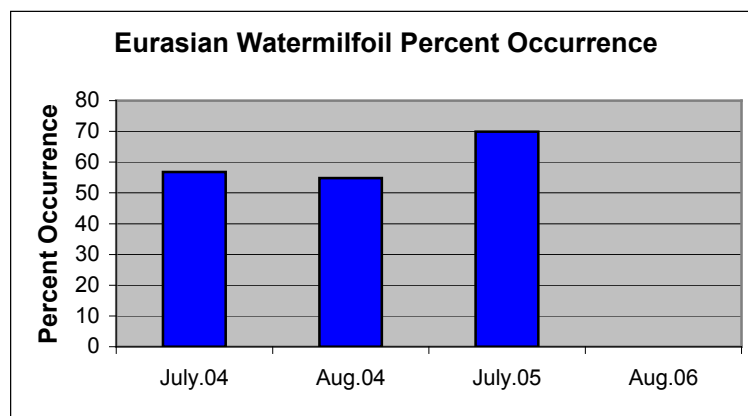
Figure 12. Griffy Lake, Eurasian watermilfoil percent occurrence in the last four surveys (July 2004 and July 2005 data collected by IDNR).

Brazilian elodea was not the only invasive exotic species found during previous sampling. Eurasian watermilfoil was also abundant prior to the fluridone application. This species is very susceptible to fluridone at low rates and was not discovered during the August 2006 sampling (Figure 12). However, there were fragments of this plant observed following a heavy rain event. It appears possible that this plant is present within the Griffy Lake watershed. Efforts are underway in an attempt to discover the location of the milfoil. Curlyleaf pondweed is another invasive exotic species in Griffy Lake. This plant was damaged by the treatment but will likely return next season due to the presence of reproductive structures called turions (curlyleaf pondweed turions are not affected by fluridone and can remain viable in the bottom sediments for several years).

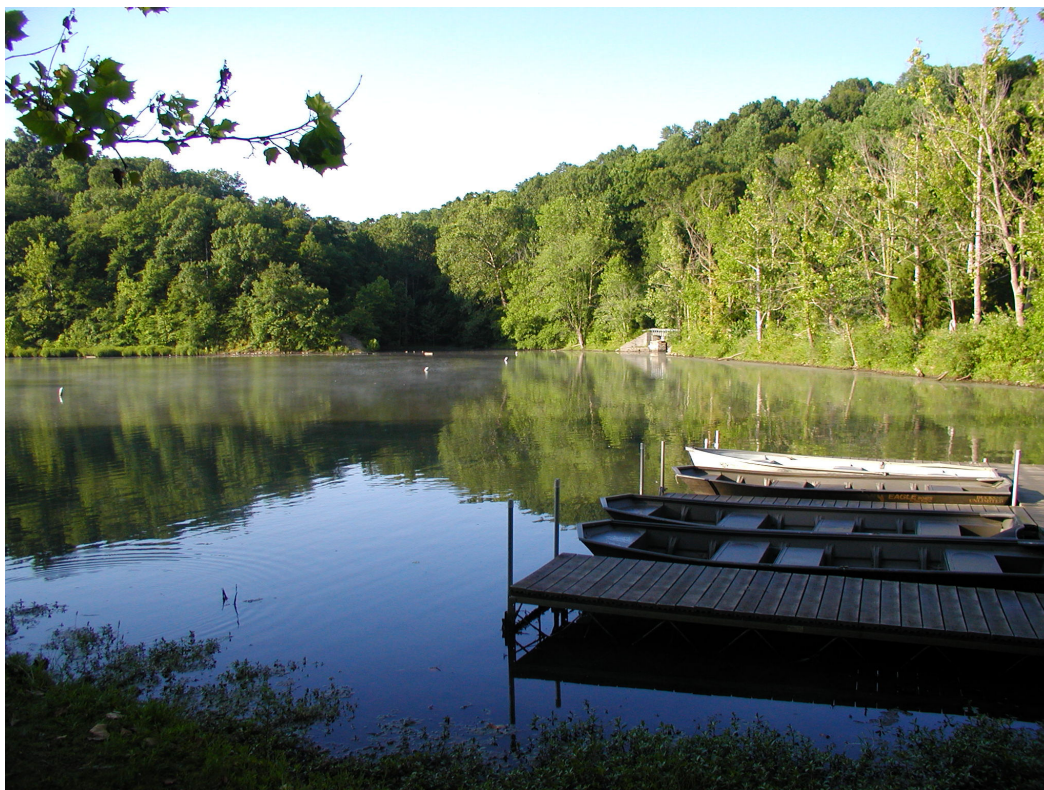
Figure 13. Photo taken on July 6, 2006 from the public access site in the upper end of Griffy Lake. Note lack of filamentous algae, which was observed earlier in the spring.

One of the main concerns prior to the fluridone treatment was that once the plants were removed, Griffy Lake would revert to a bluegreen algae dominated lake. This did not occur. There was an instance of filamentous algae growing in the upper end of the lake in late spring, but this disappeared by summer (Figure 13). Secchi measurements taken in the last three plant surveys and on five occasions in 2007. These measurements are graphically illustrated in Figure 14. Secchi measurements can be highly variable due to many environmental factors, but it appears that there was not a dramatic shift in water clarity following the treatment.

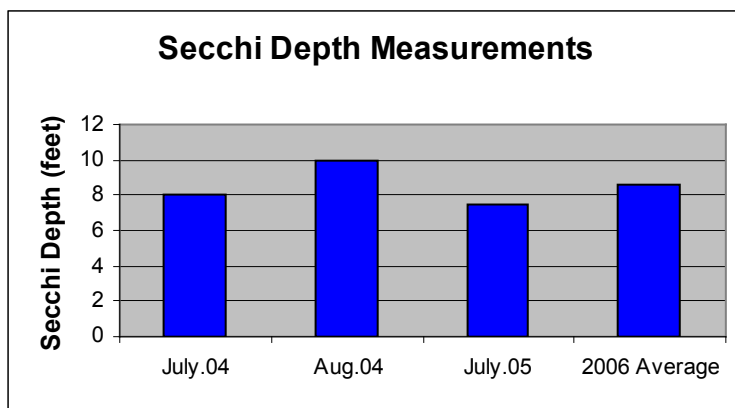
Figure 14. Griffy Lake, Secchi measurements from the last three seasons (July 2004 and July 2005 data collected by IDNR, 2006 average calculated from five measurements taken by Aquatic Control on May 1, May 11, June 15, July 7, and August 8).

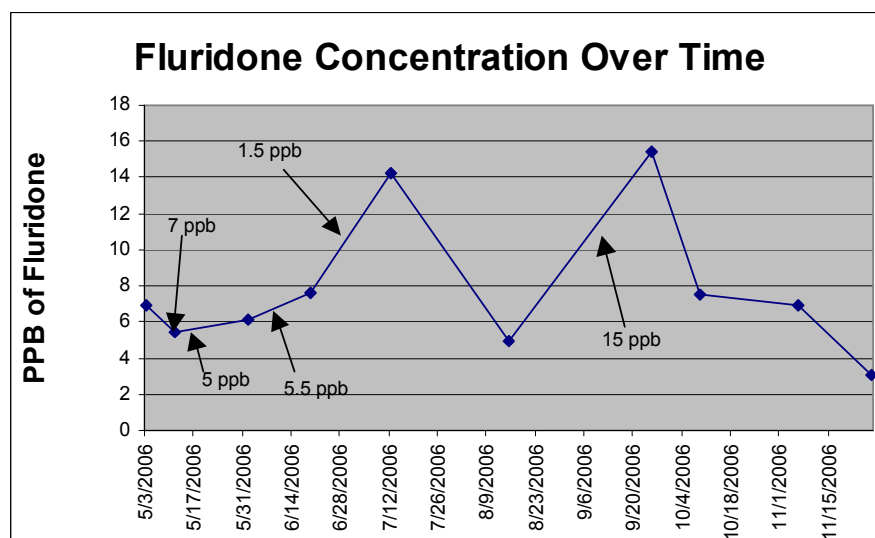
Figure 16. Fluridone concentration in Griffy Lake in 2006, based on FasTest results. Bump treatments of herbicide are shown by arrows and correspond to Table 4.

The initial treatment was originally scheduled for April 17. However, due to heavy rains, this treatment was completed on April 20. A total of 1480 pounds or a theoretical concentration of 25 parts per billion (ppb) of Sonar Q was applied on April 20 (Figure 15 and Table 4). Three FasTests, designed to monitor fluridone levels, were taken on May 1 (Figure 16). On May 11, a bump treatment was completed with 460 pounds or 8 ppb of Sonar Q and PR. On May 16 another bump was completed using Sonar Q and PR. A total of 300 pounds or 5 ppb was applied at this time. Due to heavier than expected rains it was determined that another bump treatment would be required. This treatment was completed on June 15 with Sonar AS. A total of 4 gallons or 5.5 ppb was applied. One more bump was completed on July 6 with 80 pounds or 1.5 ppb of Q. This product was applied to all three areas that still contained Brazilian elodea. Following the August survey, SePRO was contacted and asked to send out their specialist in order to determine if another bump was necessary. Dr. Tyler Koschnick and Bob Johnson inspected the lake on September 12. Dr. Koschnick estimated that the remaining few patches of Brazilian elodea had a 50/50 chance at surviving into next season. He recommended that another bump treatment be completed as soon as possible. The reasoning was that the remaining Brazilian elodea was already severely damaged and one more bump would likely finish it off. The last bump treatment was completed on September 19 with 10.5 gallons or 14.5 ppb of Avast! Herbicide (fluridone is also the active ingredient in Avast!). A summary of the treatments is illustrated in Table 4 and a summary of the FasTest results is illustrated in Figure 16.

It does not appear that a 12 ppb average concentration was ever maintained for 60 consecutive days (there may have been a total of 60 days over 12 ppb, but not consecutively). However, it appears that 6 ppb of fluridone was present in Griffy lake for over 180 consecutive days. According to some researchers, long exposures to fluridone at lower rates may be more effective than short exposures to higher rates. Long exposures at low rates are typically more difficult to achieve due to dilution, so most applicators are hesitant to attempt this type of treatment. Despite the use of formulations designed for slower release of fluridone, the initial concentration never reached the predicted levels due to heavy spring rainfall. Figure 17 is a picture of the overflow of Griffy Lake, shortly after the initial treatment.

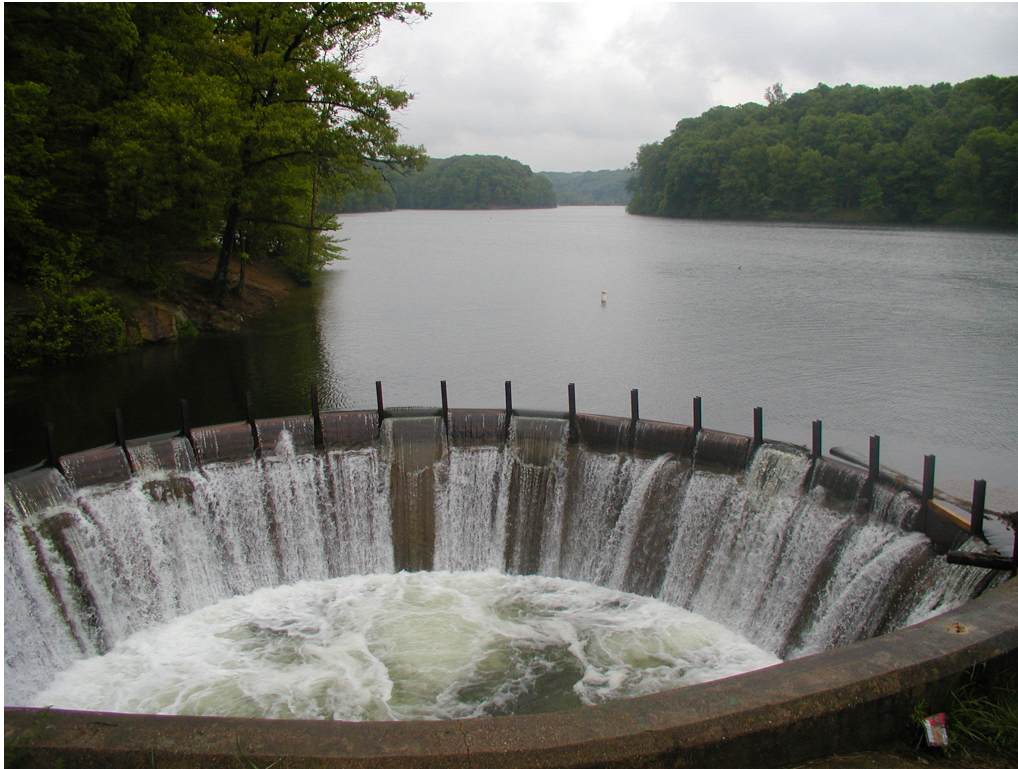
Figure 17. Overflow of Griffy Lake, May 11, 2006.

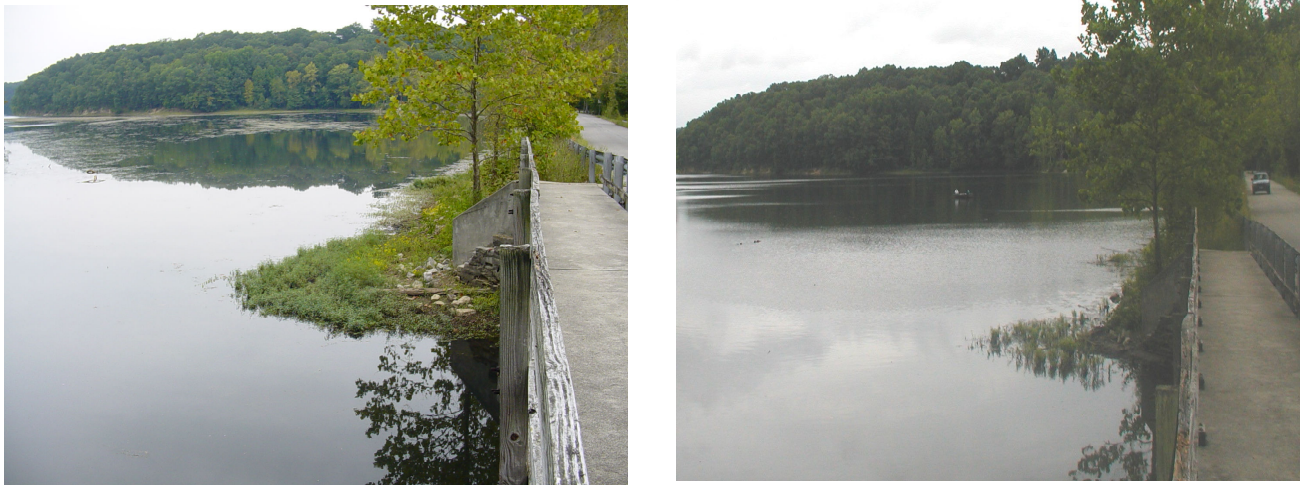
Figure 18. Photo taken of Griffy Lake on August 20, 2004 compared to photo taken of same area on July 6, 2006.

Despite the loss of product from a wet spring and summer, the whole lake treatment of Griffy Lake was successful. Following the treatments, Eurasian watermilfoil, curlyleaf pondweed, and Brazilian elodea were no longer a nuisance to fishermen and lake users (Figure 18). There was very little Brazilian elodea remaining by the August survey. That which was present appeared to be damaged from the treatment. In addition, the final application was made in September to be certain that the damaged plants did not survive and only a single black stem was discovered in subsequent informal sampling.
